Comprehensive analysis of local corrosion degradation on austenitic pipeline

Abstract. Corrosion degradation was observed in a nuclear power plant spent fuel cooling system. A systematic and comprehensive investigation program was developed to reveal the root cause of the degradation. Series of corrosion tests, mechanical, microstructural and microbiological investigations were carried out. Also, simulations of the operating conditions and welding parameters were performed. Based on the results, the major contributors to the degradation process were identified and a possible degradation mechanism was proposed.

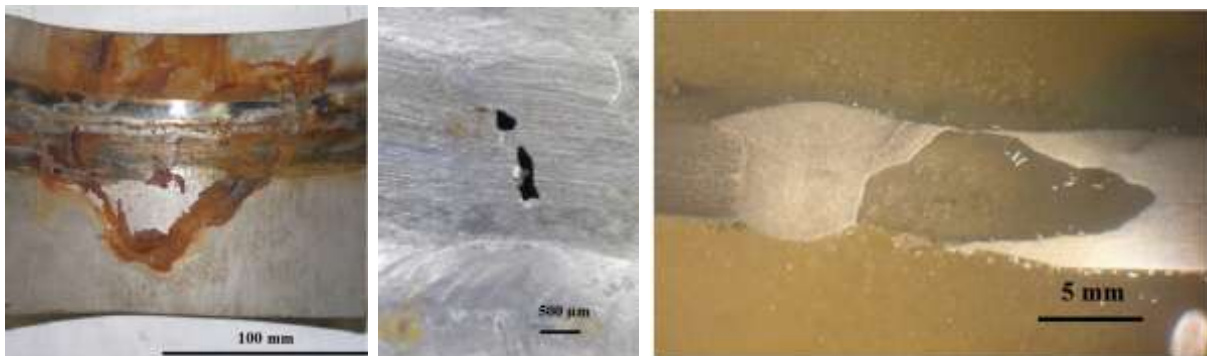
After 26 operating years, leakage was observed in the spent fuel pool cooling system at the Paks Nuclear Power Plant, Hungary. The cooling medium is boric acid with a concentration of $> 14.5 \text{ g}\cdot\text{dm}^{-3}$; and average temperature of $\sim 30^\circ\text{C}$. Two parallel loops operate alternately. Results of the immediate non-destructive examinations and subsequent comprehensive investigations made it clear that the leakage was caused by pitting corrosion on the inner surface of the cooling system pipelines. Some of the pits penetrated through the whole wall thickness. The structural material of the pipelines is Cr-Ni-alloyed, Ti-stabilized austenitic stainless steel (08Ch18N10T, nearly equivalent with steel 1.4541). The diameters vary from 100 to 300 mm; the wall thickness range is 6 to 10 mm. The pipes were laid down in concrete which made their investigations and subsequent replacements difficult and time consuming. *Figure 1* shows a through-wall pit detected by visual inspection and ultrasonic examination as well (left: corrosion products around a circumferential weld; middle: two pits after cleaning and decontamination; right: cross-section with the through-wall damage).

Figure 1. Pitting corrosion around the welded joint – pipe: Ø 219x10 mm (left: as is, middle: after cleaning, right: cross-section with the inside down)

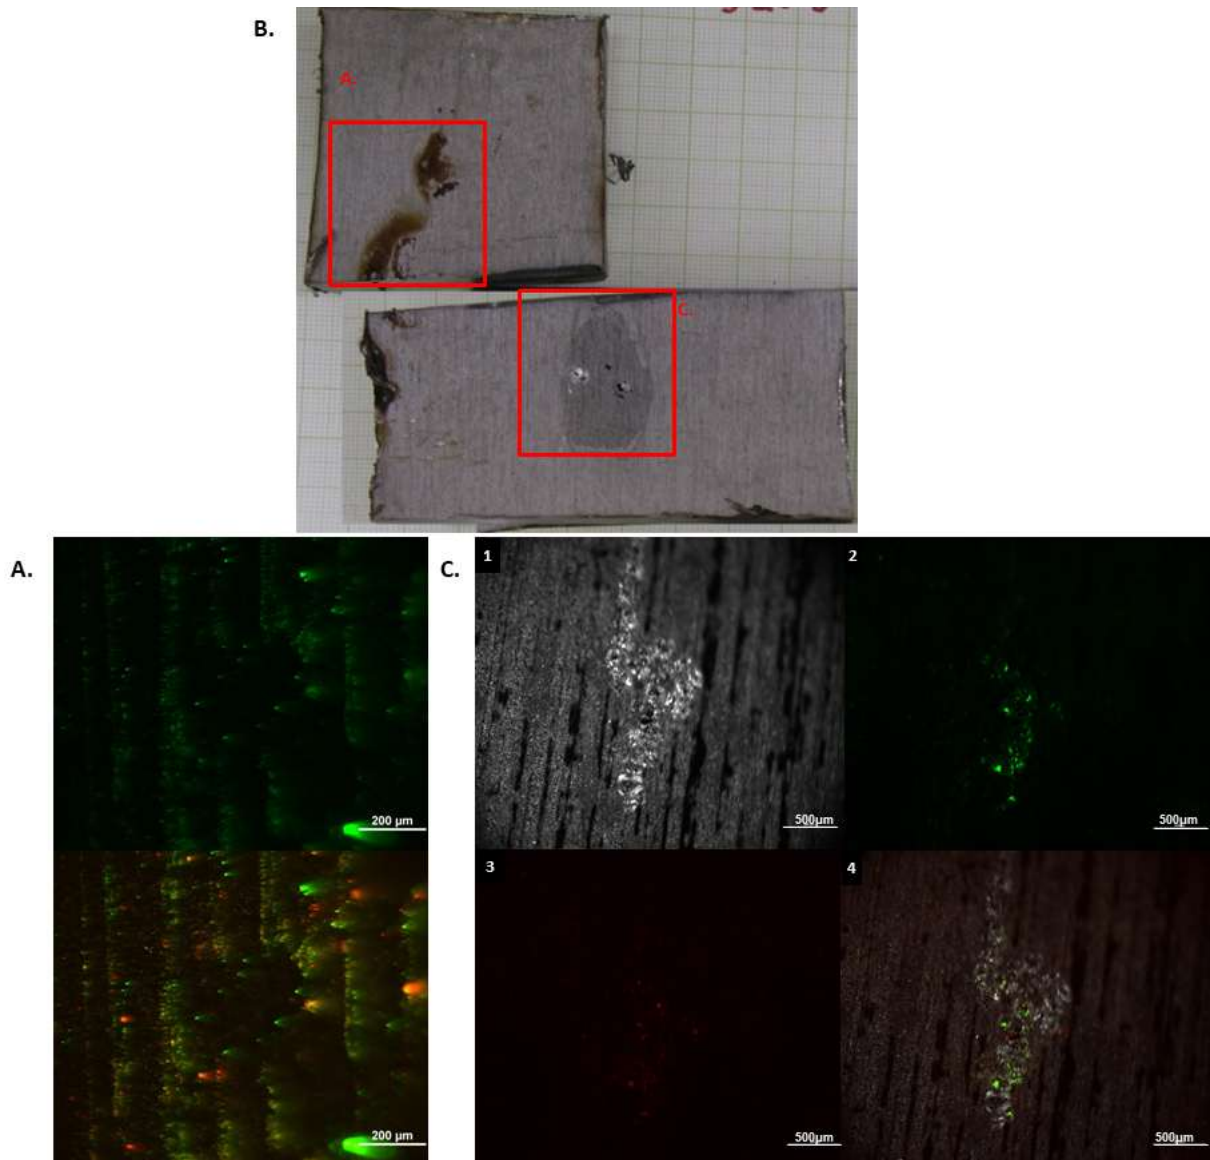
3.1.1. Effect of microbes on the corrosion phenomena. Over a two-year period, we were monitoring biomass changes in the bulk medium and found that most of the time the biomass was in the range of 10^2 - 10^3 ME·mL⁻¹, sometimes increasing up to 10^4 ME·mL⁻¹ (ME = microbial equivalent, cells). Next generation sequencing of the bulk medium revealed that the majority of the microbes is *Ralstonia pickettii*, a mixotrophic species viable in ultrapure water [2, 3]. It can live in an autotrophic manner by using only H₂ as a sole source of energy and CO₂ as the sole carbon source. It is known to produce extracellular polymer material, a matrix needed for biofilm development. The sequencing revealed members of the *Desulfobacteriaceae* and *Desulfovibrionaceae* family, members of the *Burkholderia* family, the *Sediminbacterium* genus that have been implicated in iron oxidation [4], as well as the acid producing *Acinetobacter* genus [5] that has been shown to be a pioneer bacterium in biofilm development [6, 7]. Although the amount or the type of microbes present in the bulk fluid does not represent microbes on the surface, the results suggest that *Ralstonia pickettii* together with other *Ralstonia* species might initiate biofilm development in the presence of boric acid. Biological activity reaction test (BART) [8] performed on corrosion products collected from the bottom of the pipes revealed the presence of both iron oxidizing and iron reducing bacteria, heterotrophic micro-organisms, slime forming bacteria, as well as acid producing bacteria. Sulfate reducing bacteria were not detected. Corroded areas were analyzed by fluorescence staining to visualize live and dead cells inside the pit after cleaning (*Figure 2C*) and on corrosion deposit (*Figure 2A*).

Figure 2. Fluorescence staining of corroded stainless steel.

A. Live cells (upper) and merged image (lower) of corrosion products; B. The corroded surface; C. (1) bright field image, (2) live cells, (3) dead cells, (4) merged image

The pit had a shiny metallic surface (*Figure 2B*: lower picture) suggesting an active corrosion mechanism, and live/dead stain revealed microbes inside the pit but not outside (*Figure 2C*).

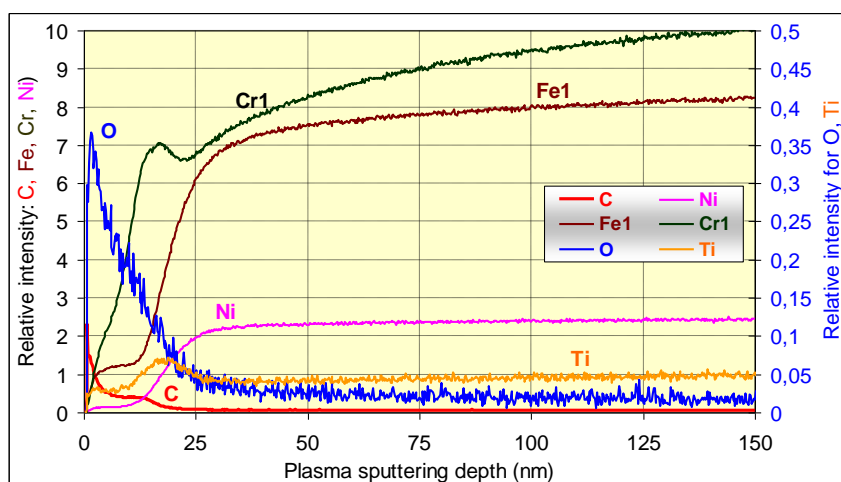
The glow discharge optical emission spectroscopy (GD-OES) is capable of measuring the layer's thickness and determining its tentative chemical composition. In *Figure 4* the GD-OES intensity measured on the transition to HAZ can be seen. First of all, the oxygen content and the distribution of Ni, which has a low inclination to migrate can indicate the boarder of the oxide layer with the thickness being approximately 10 nm. In the middle of the HAZ the thickness approaches 50 nm while on the normal surfaces the passive layer thickness does not exceed 3-4 nm. Intensity of Fe, Cr and Ni

Figure 4. GD-OES intensity of various elements as a function of the sputtering depth, on clean surface

reaches the value characterizing the base material at this depth. The oxide layer's composition is detrimental from the corrosion's point of view because it contains less Cr than the normal passive layer

and has a less beneficial Cr-oxide/Cr and Cr/Fe ratio. On the other hand, during the evolution of the thicker oxide layer more Cr will be detracted from the area beneath the scale than in the case of a normal passive layer.

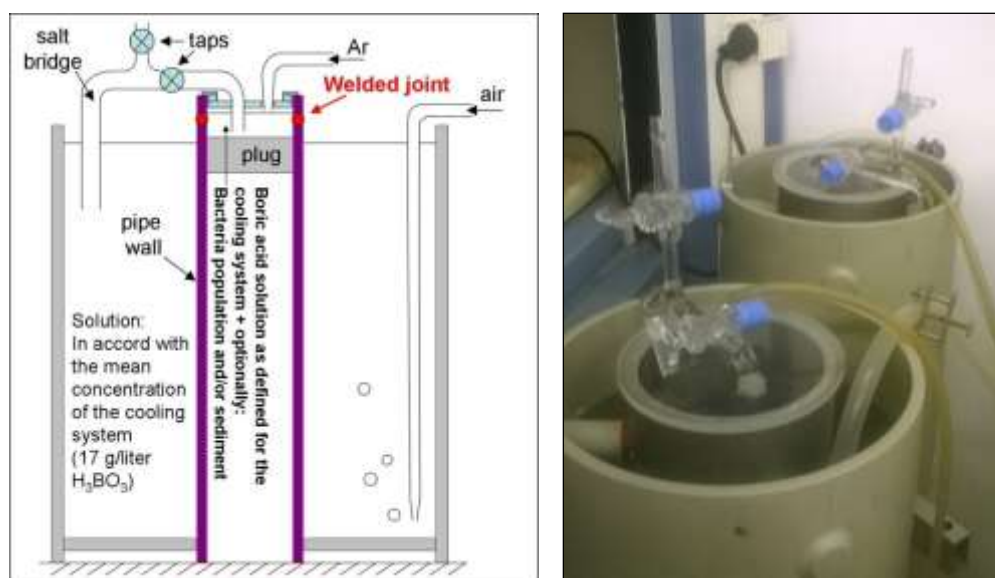
- Long term operation (46 days) of differential aeration cells with large cathode/anode surface ratio confirmed the extreme corrosion sensitivity of weld produced without proper protection. These samples showed approximately ten times faster corrosion velocity than the samples without welds.
- Also, simulation of differential aeration in anaerobe environment revealed biofilm development on surfaces of solid materials. It occurred even in the presence of boric acid. A biofilm is considered as a potential initiation factor for microbiological corrosion degradation.
- On the weld root side of the specimens, the initiation stage of pitting corrosion could be observed, as well as indications for tuberculum development were found. It is to be emphasized that these degradation processes developed in a relatively short time.

Figure 6. Setup of the differential aeration model (left) and the equipment (right)
